# Best practice management and wise use of the wetlands at Sydney Olympic Park

Swapan Paul  
Sydney Olympic Park Authority

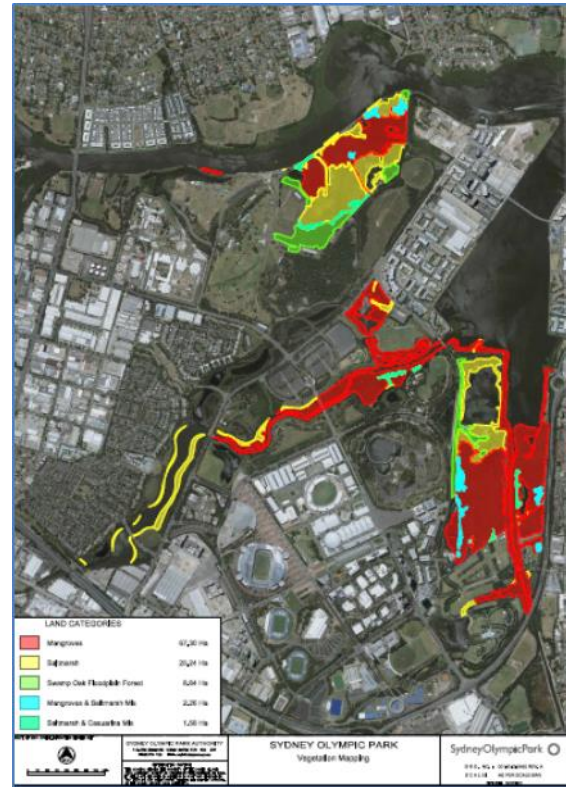
Figure 2. Spatial Distribution of Estuarine Wetlands.

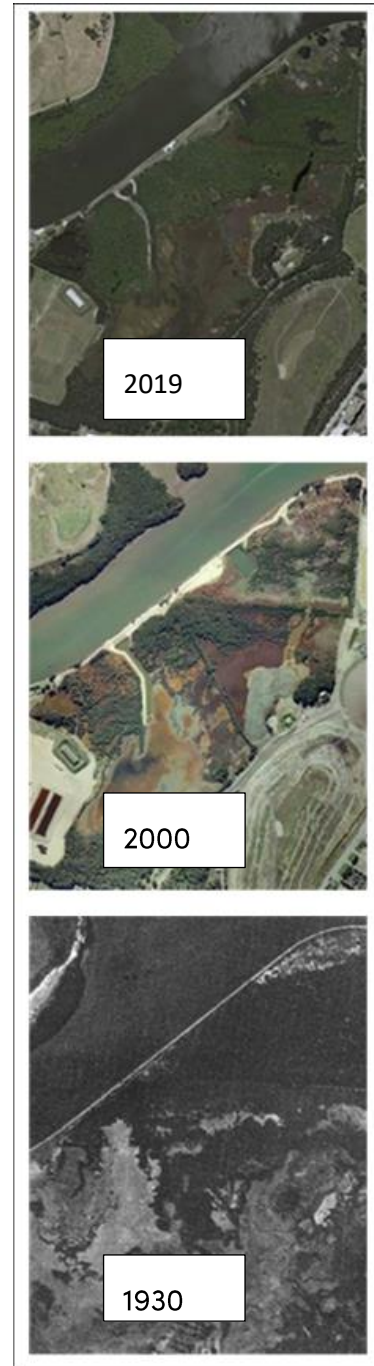
Figure 4. Major changes in the condition of the area that is now Newington Nature Reserve Wetland

This wetland was reconnected to the adjacent Parramatta River after over 150 years of separation (Table 1). The new connectivity was established in 1997 and 2001 through construction of drainage and tidal flushing corridors (Figure 4). This has augmented drainage of the once stagnant water and facilitated tidal exchange. Because of the sudden drainage of the once stagnant water through the new corridors; those caused some abrupt changes in the wetland in the forms of acid sulfate release, stress on Swamp Oak Floodplain Forest (SOFF), change in the texture of the mud in the extensive mudflats that used to be heavily used as feeding grounds by migratory shorebirds, rapid expansion of coastal saltmarsh, salinity loss by the planted saltwater tolerant rare and threatened species on the upper marsh in the nursery area and stress on mangroves. Over time, those ecosystems have been undergoing fast adaptations and slowly but surely turning in to significantly beneficial habitats.

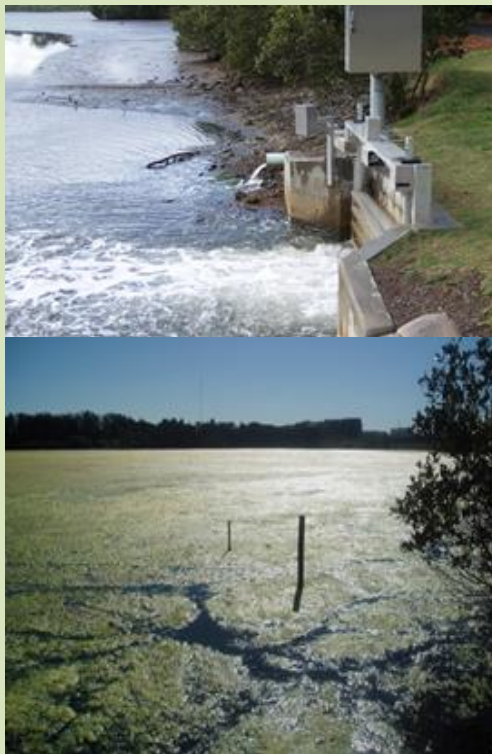
**Box 1. Tidal restoration in the WBR.**

In the past, the Refuge was largely isolated from tidal exchange with the Parramatta estuary, which resulted in the wetland becoming stagnant; bird diversity and abundance declined, and algal blooms became common. A small pipe installed through the bund in the early 1990s allowed some tidal exchange, but conditions did not change for the better until a 2m wide automated, solar-powered tidal gate and weir was installed in 2007, allowing daily exchange of tides. Water flow can be adjusted seasonally and daily to account for tidal cycles and habitat needs. High tides flushed the wetlands of algae as well as discouraged new algal growths. The number and diversity of benthic invertebrate, an important component of migratory shorebirds' diet, increased. With no delays, a huge number of Bar-tailed Godwit made a comeback after decades of absence.

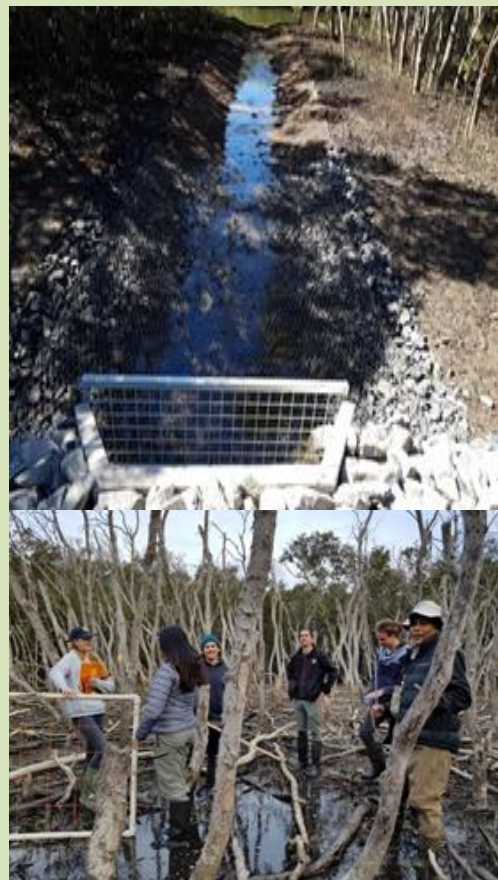
**Box 2. Recent restoration of Badu Mangrove dieback area.**

Grey Mangrove trees died in an area of approximately 7,000m<sup>2</sup> within Badu Mangroves precinct during 2012 and 2013. Several investigations confirmed that the most likely cause was long-term water-logging. Following careful planning a bypass corridor was constructed by placing a box culvert and excavating two linking channels. The construction of the by-pass corridor has instantly removed the water-logging. Mangrove trees that were earlier stressed made a comeback and new seedlings are colonising. A scientific monitoring program has been in place to track the temporal changes.

Recent initiatives have improved the overall conditions of mangroves in the Park. A most recent example has been the installation of a bypass corridor to allow drainage of a waterlogged area and allow a natural regime of tidal exchange. Box 2 provides some more insights.

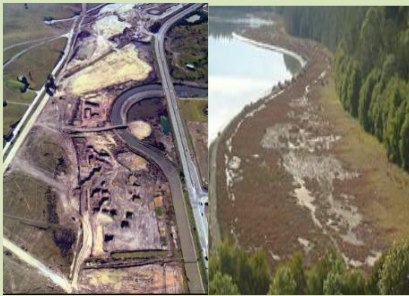
### Box 3. Saltmarsh reconstruction and rehabilitation in Haslams Flats.

Sydney Olympic Park has a long history of active management of saltmarsh. Remediation works in the 1990s included several major estuary restoration projects. Remnant coastal saltmarsh was conserved and a nursery established to provide local provenance seed and cuttings used in replanting programs. The concrete-lined channel of Haslams Creek was replaced with a new creek-bed and newly-built tidal mudflats were planted with saltmarsh. This was further rehabilitated in 2007.

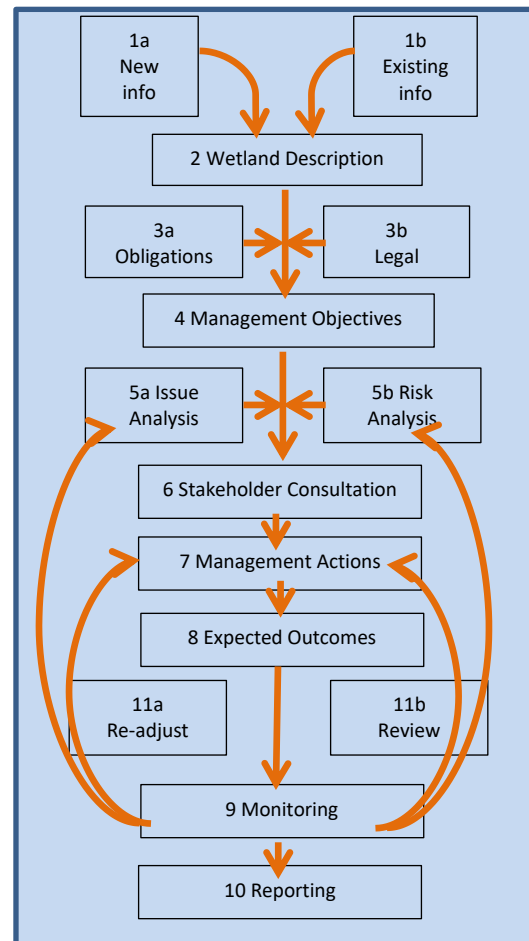
Figure 6. Adaptive Management Framework (re-constructed after SOPA 2006).

- i. defining a management issue and drawing hypothesis that are based on scientific investigations and monitoring;
- ii. undertaking risk analysis;
- iii. setting management goals;
- iv. undergoing genuine consultations with relevant stakeholders;
- v. undertaking impact assessments and setting management actions;
- vi. monitoring outcomes of management actions;
- vii. evaluating the outcomes and re-setting goals (if needed);
- viii. undertaking research and following the management loop.

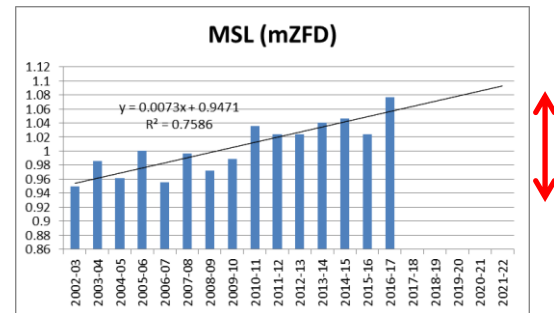
Figure 7. MSL and trend line in Sea Level Rise in Sydney Olympic Park.

The Authority's own studies, which are based on the data gathered by the NSW Manly Hydraulics Laboratory's tidal data from this site, have concluded that more than 7.00mm of average annual sea level rise in this site over the past 14 years, starting from 2002-03. This corroborates to that concluded in another independent study included in this eBook. In fact, in some years the rise was many-times higher and particularly in 2016-17 period, it rose by 55.0mm (Figure 7). The above rises mean that the estuarine wetlands are under tremendous pressure from the rising sea level. According to this trend line, the

level in 2022 will reach 140mm above the 2002-03 level.
